Reservoir Survey

Date: 01-Aug-2017

Surveyed River Area: From Muskrat Falls Site to Gull Island Site

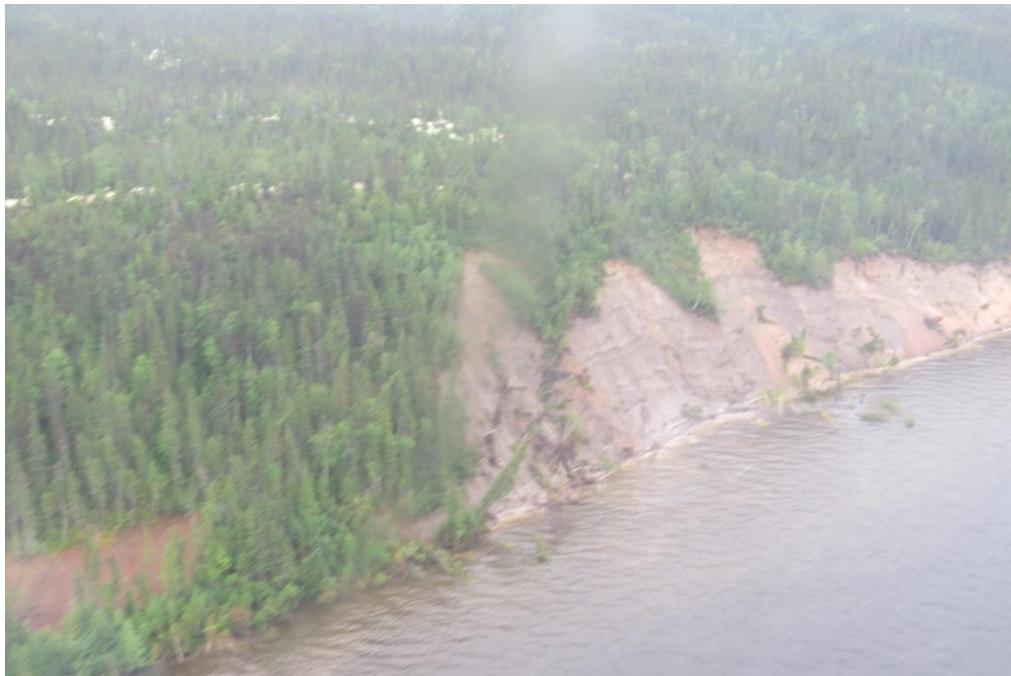
Figure 1: Between 67 to 68 Km, South Bank

Kilometer	Sedimentation/Shoals	Slopes/Sloughs/Slides	Conditions
44 to 48	None	None	Normal
48 to 51	Shoals along the edge	None	Slow Erosion
51 to 60	Some shoals visible	None	Mostly green covered
60 to 66	Some shoals	None	Mostly green covered
66 to 68	None	Two fresh slides – No change since last inspection	Active erosion
68 to 70	Shoals	Small slope failures	Active erosion
70 to 72	None	None	Green covered
72 to 78	Some shoals visible	Small slope failures	Mostly active erosion
78 to 81	Shoals	Small slope failures	Active erosion
81 to 84	None	None	Stable (Green and Gravel beach)
84 to 85	None	Fresh slides – not new	Rapid water
85 to 88	None	None	Stable (Green and Gravel beach)
88 to 90	None	Two fresh slides	Some active erosion
90 to 92	Shoals	None	Gravel beach banks – stable
92 to 95	Shoals with gravel on top	Steep slopes with no green	Active erosion

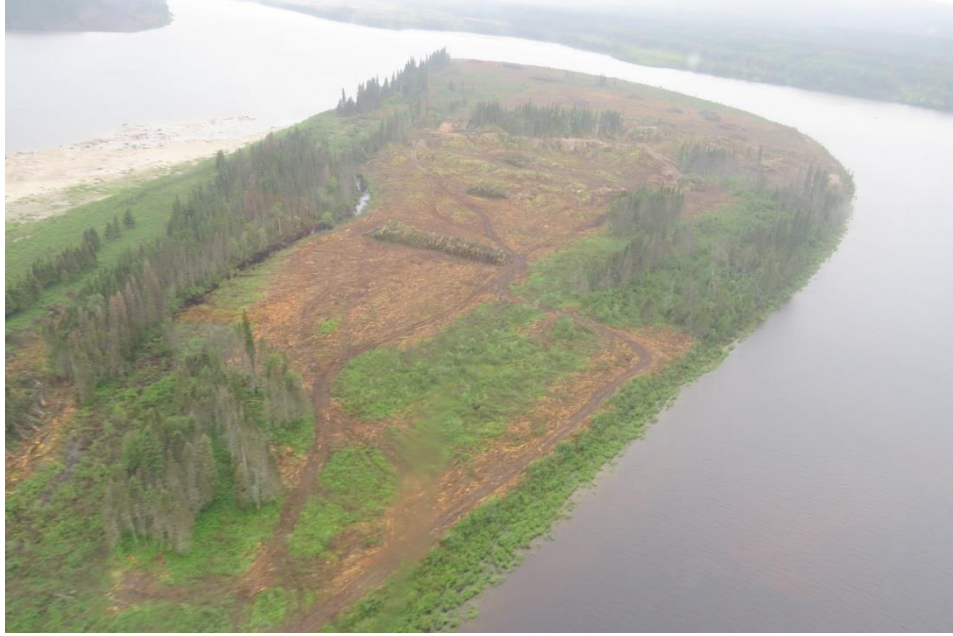
Figure 2: Edwards Island being cleared

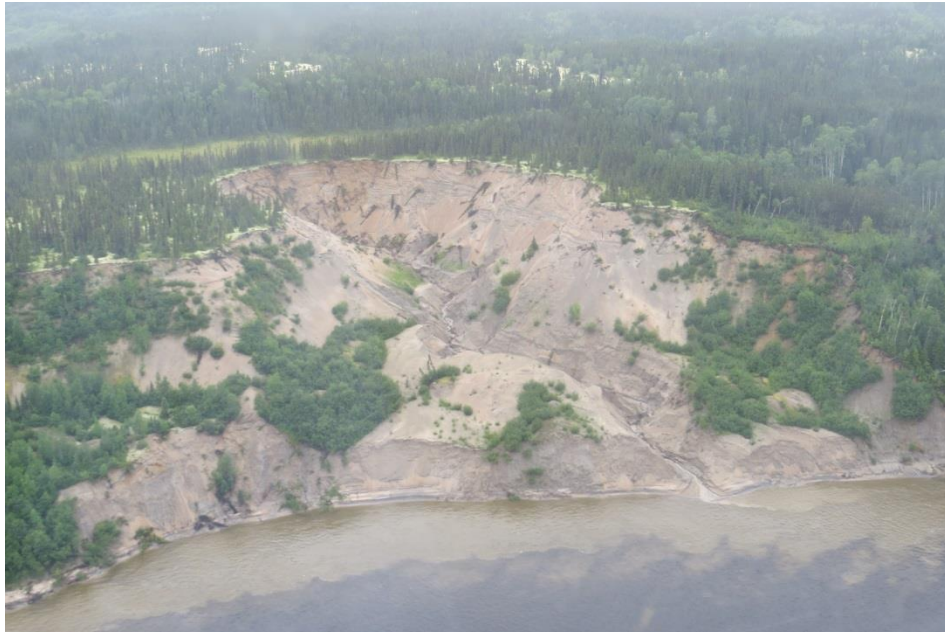
Figure 3: At approx. 49 km, North Bank (Groundwater flow with Sedimentation in the river)
