Reservoir Survey

Date: 19-Aug-2017

Surveyed River Area: From Muskrat Falls Site to Gull Island Lake

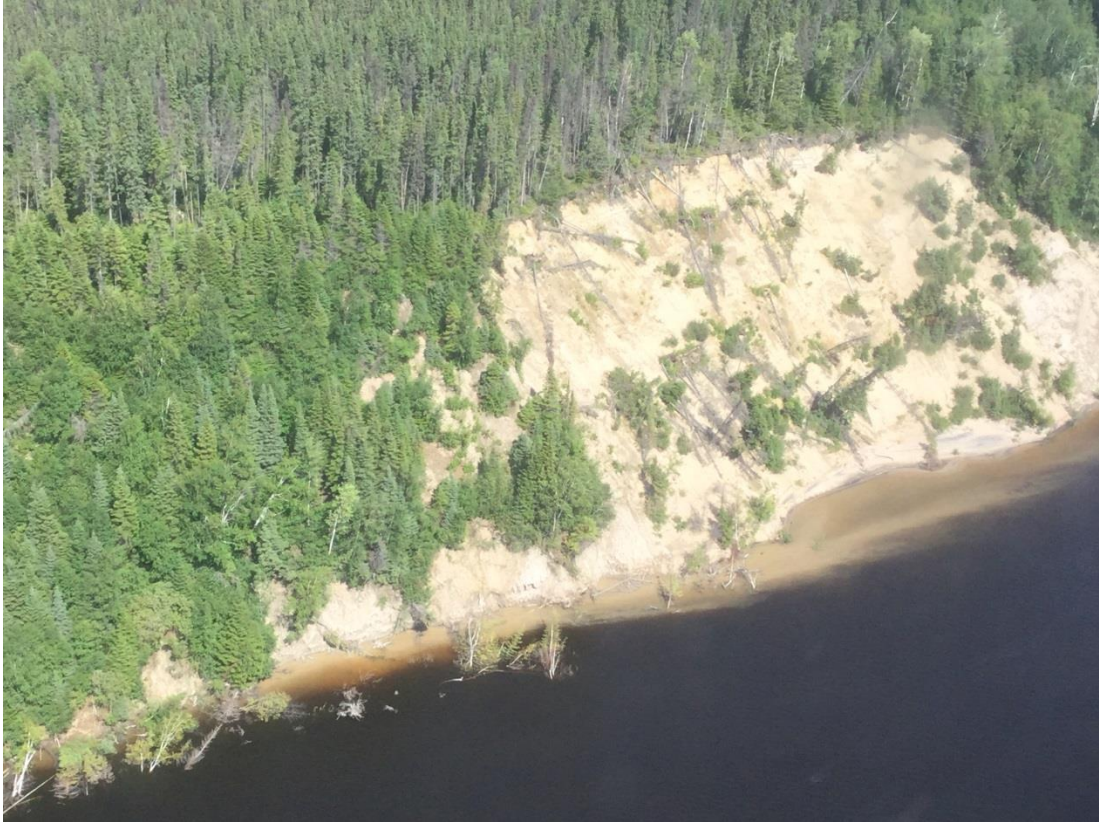
Km 46 to 49, Active erosion and sediment in water (Picture 1)

No change since last inspection, erosion is a consequence of wave effect mainly. Erosion progress slowly.

Figure 1: Between 47 to 49 Km, South Bank (Active Erosion)

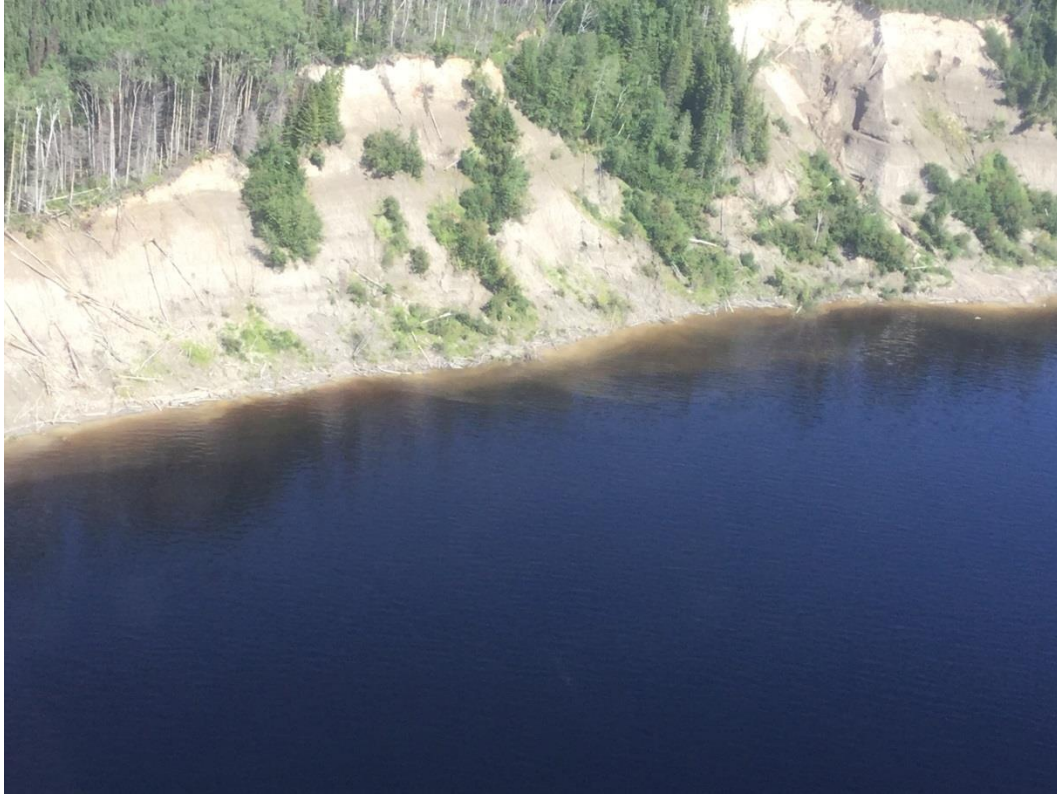
Km 58 to 60.5, Active erosion (Picture 2)

Figure 2: About 60 km North Bank, some sediment (active erosion)
