Reservoir Survey

Date: 27-Jul-2017

Surveyed River Area: From Muskrat Falls Site to Gull Island Site

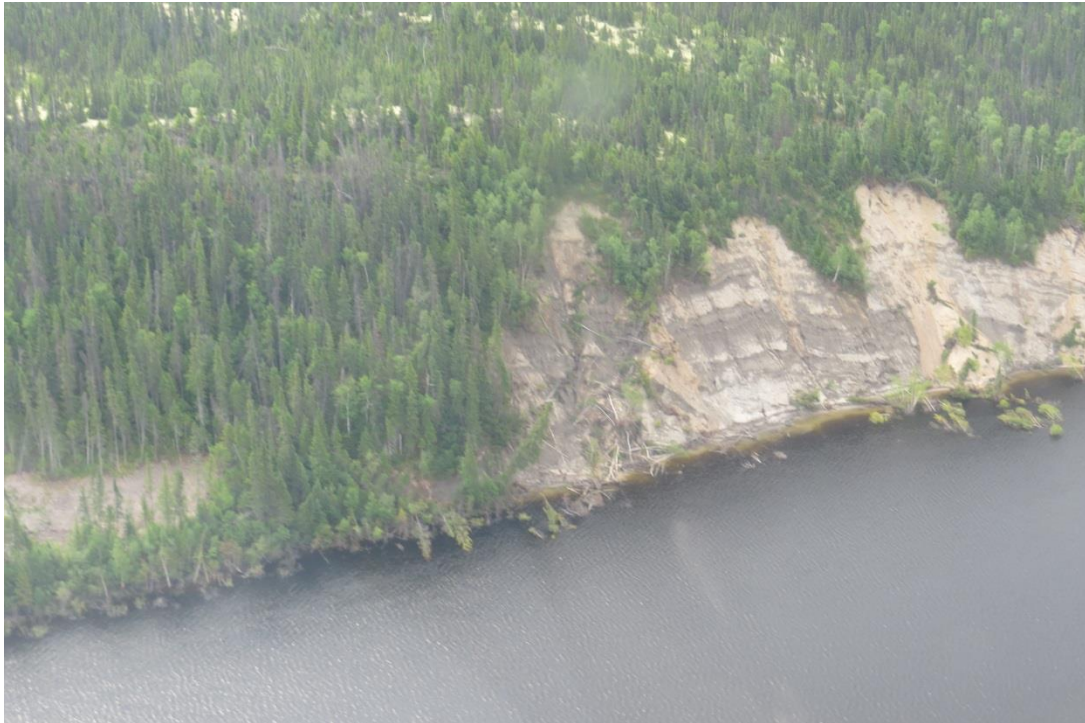
Figure 1: Between 67 to 68 Km, RightBank

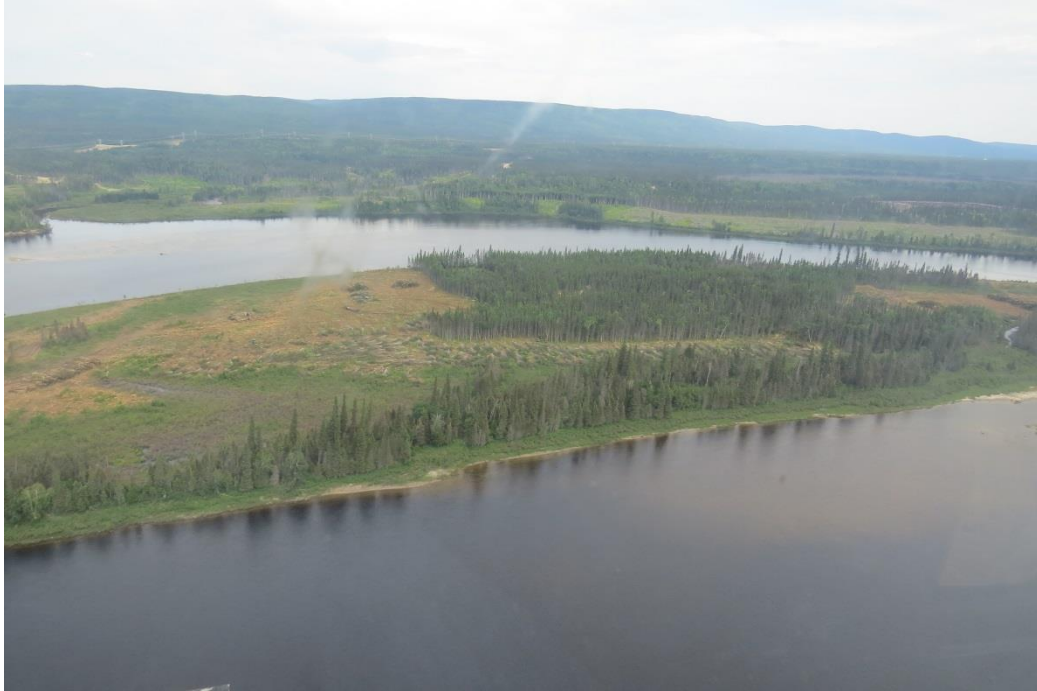
Figure 2: Edwards Island being cleared

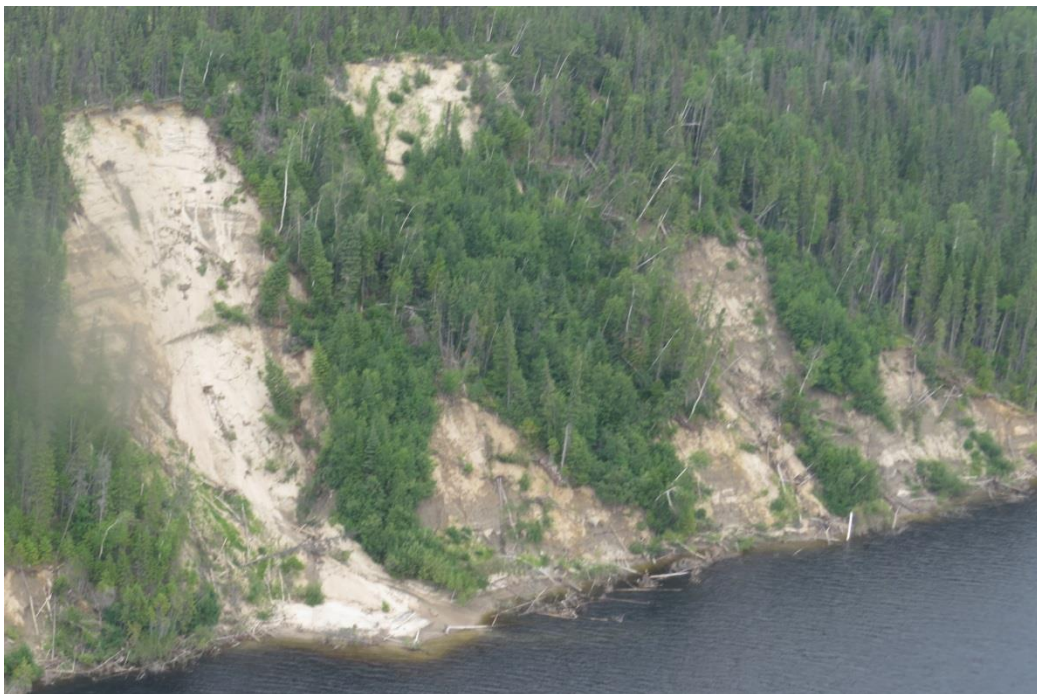
Figure 3: About 78 km, Left Bank
