## Reservoir Survey

**Date:** 08-Aug-2017

**Surveyed River Area:** From Muskrat Falls Site to Gull Island Site

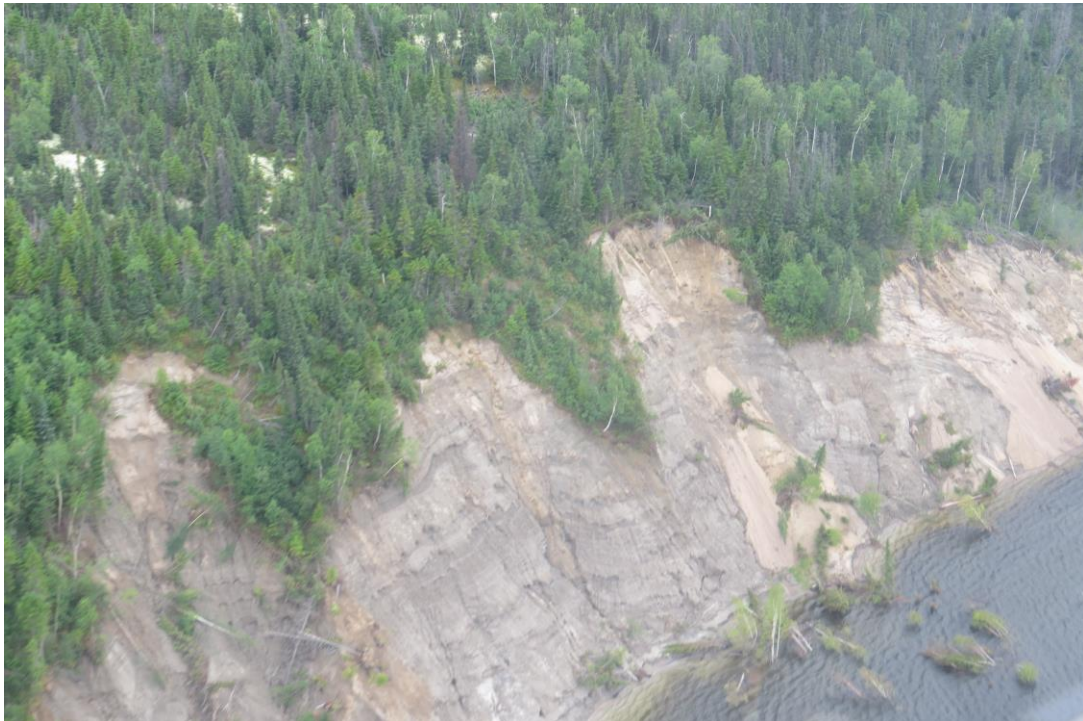
**Figure 1: Between 67 to 68 Km, South Bank (Active Erosion)**

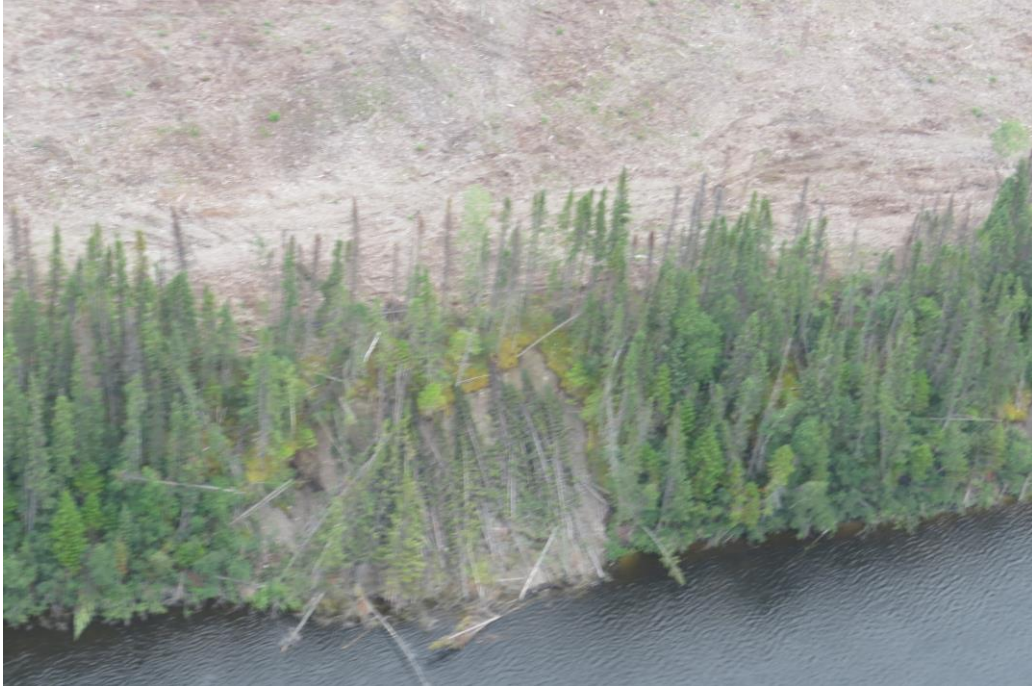
Heavy sedimentation was observed between kilometers 49 to 44 on the North Bank of the reservoir. Two new small slides were observed around kilometer 69 on the South Bank. All actively eroding areas are subjects to slow erosion due to sand and gravel deposits at the toe. No unusual conditions to report at this time.

**Figure 2: New slide at 69 km, South Bank**

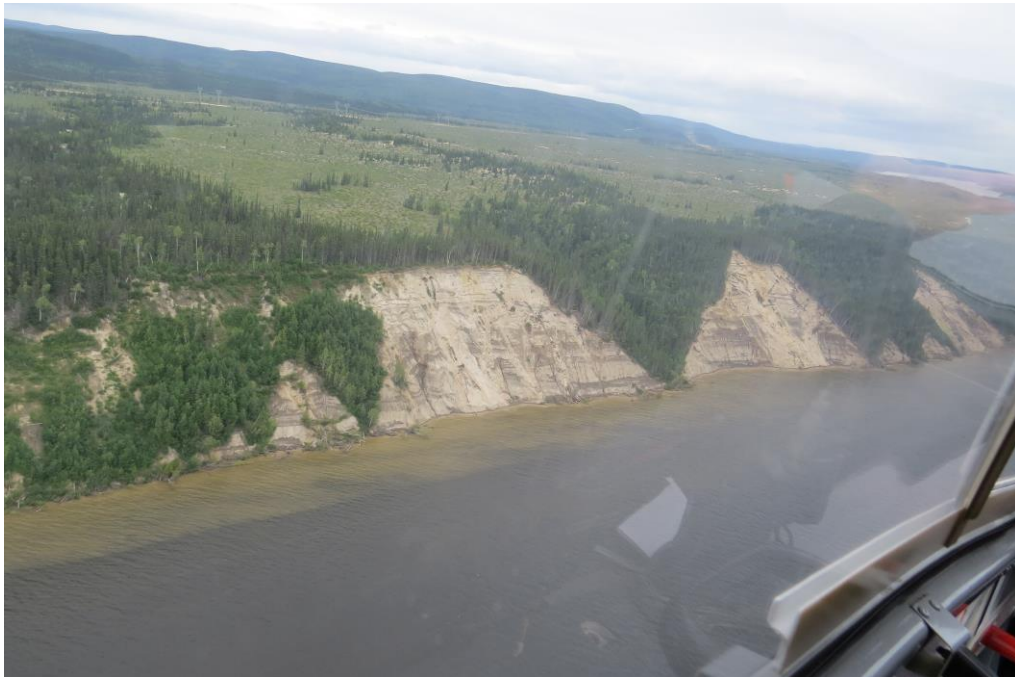
**Figure 3: About 58 km, North Bank, Sedimentation**

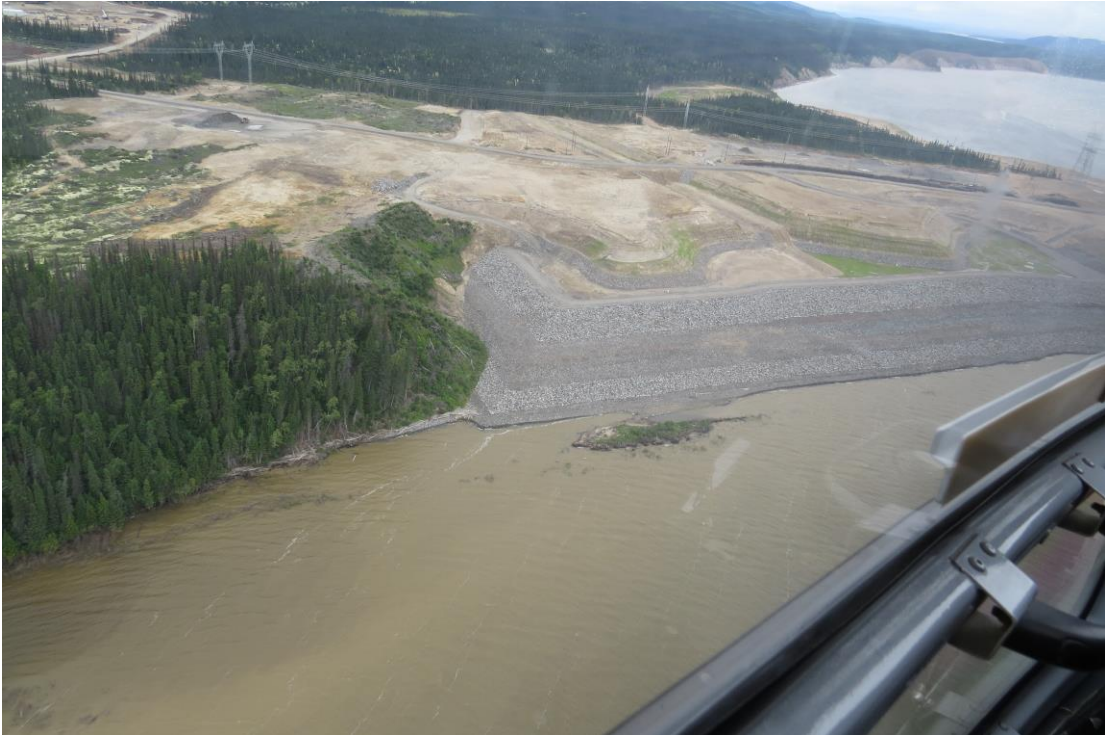
**Figure 4: North Bank 45 km, Heavy sedimentation**
