Reservoir Survey

Date: 15-Aug-2017

Surveyed River Area: From Muskrat Falls Site to Gull Island Lake

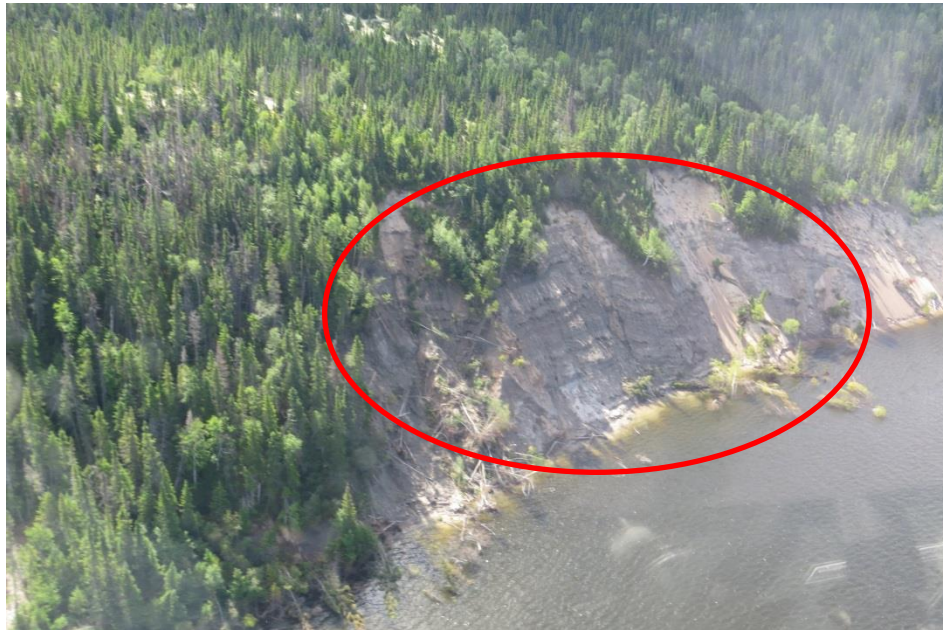
Figure 1: Between 67 to 68 Km, South Bank (Active Erosion)

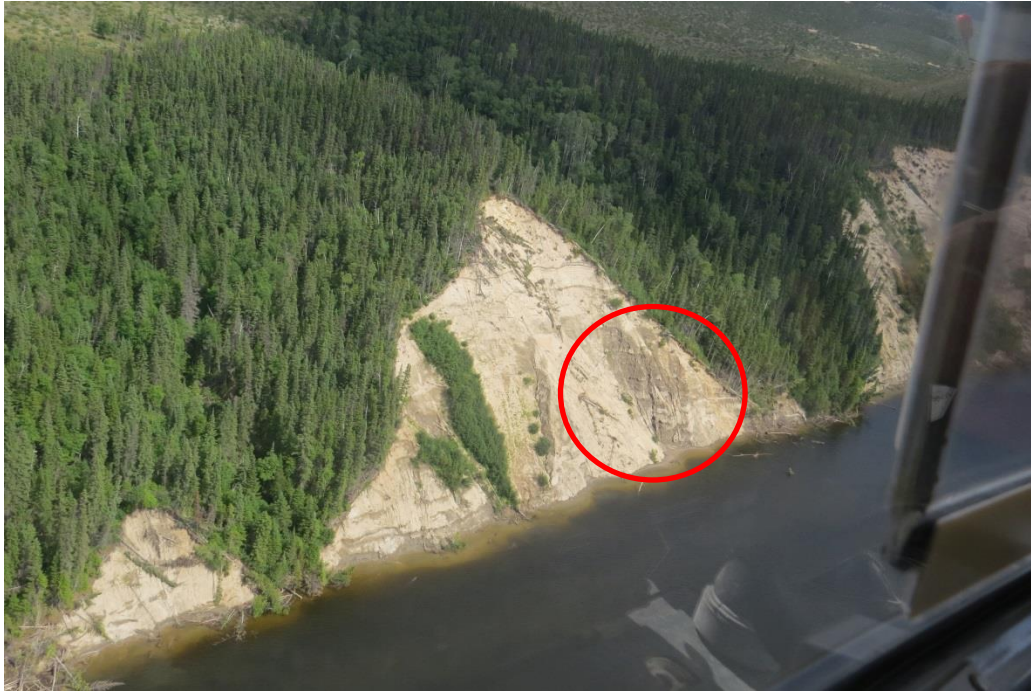
Erosion ongoing in sloped surfaces with no green cover and some sediment was still observed between kilometers 49 to 44 on the North Bank of the reservoir. No unusual conditions to report at this time.

Figure 2: About 48 km North Bank, some sediment (active erosion)

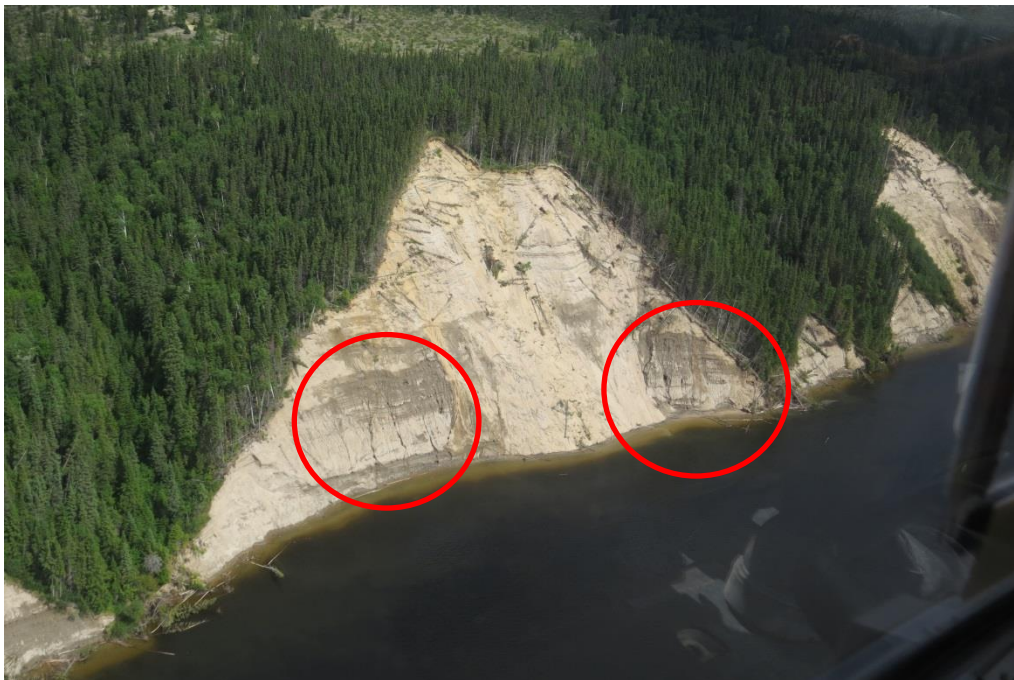
Figure 3: Kilometer 48 North Bank, active erosion
