Reservoir Survey

Date: 22-Aug-2017

Surveyed River Area: From Muskrat Falls Site to Gull Island Lake

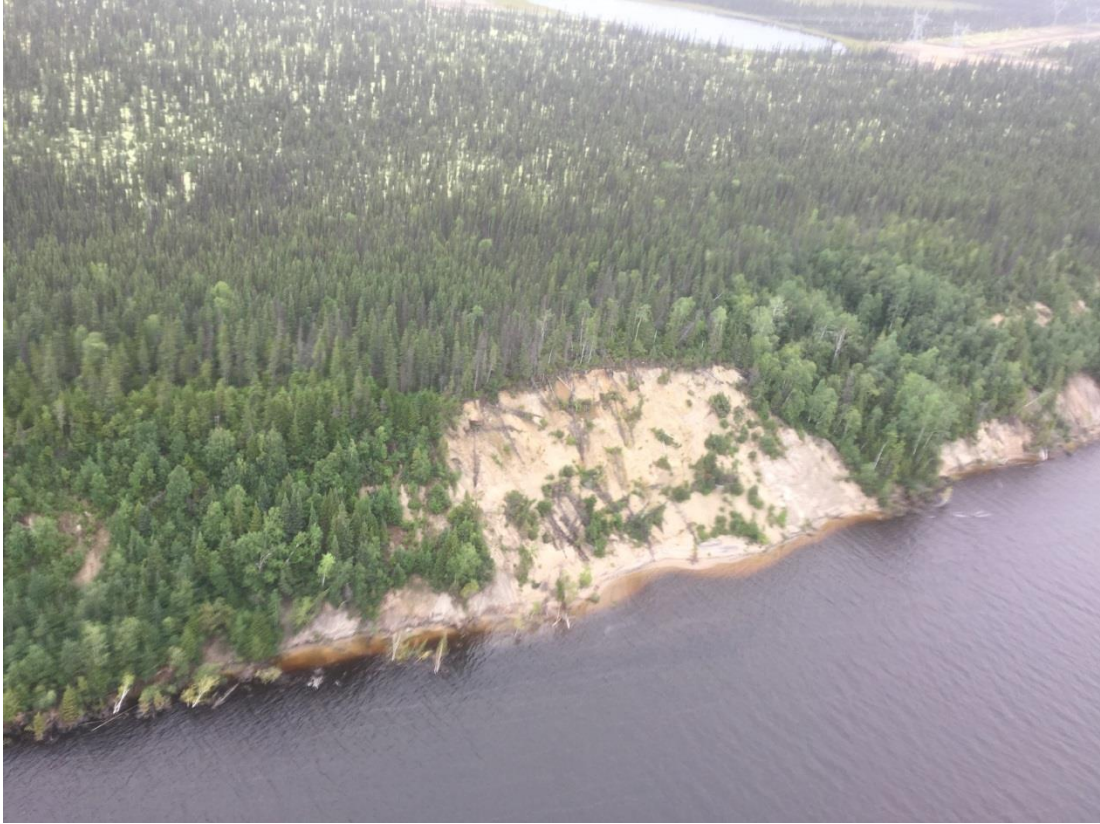
Km 46 to 49, Active erosion and sediment in water (Picture 1)

No noticeable change since last inspection, erosion is a consequence of wave effect mainly. Erosion progress slowly.

Figure 1: Between 47 to 49 Km, North Bank (Active Erosion)

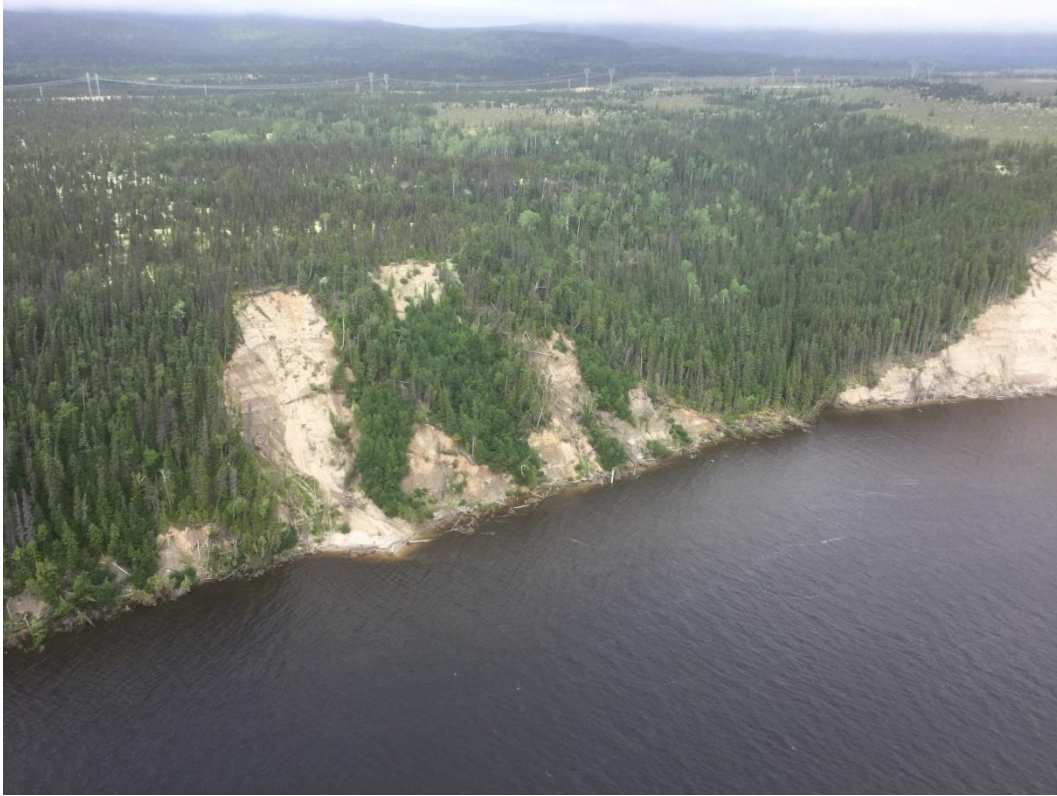
Km 58 to 60.5, Active erosion (Picture 2)

Figure 2: About 59 km North Bank, some sediment (active erosion)
