Reservoir Survey Report

Date/Time: 02-Sep-2017/11:00 PM

Surveyed River Area: From Muskrat Falls Site to Gull Island Lake

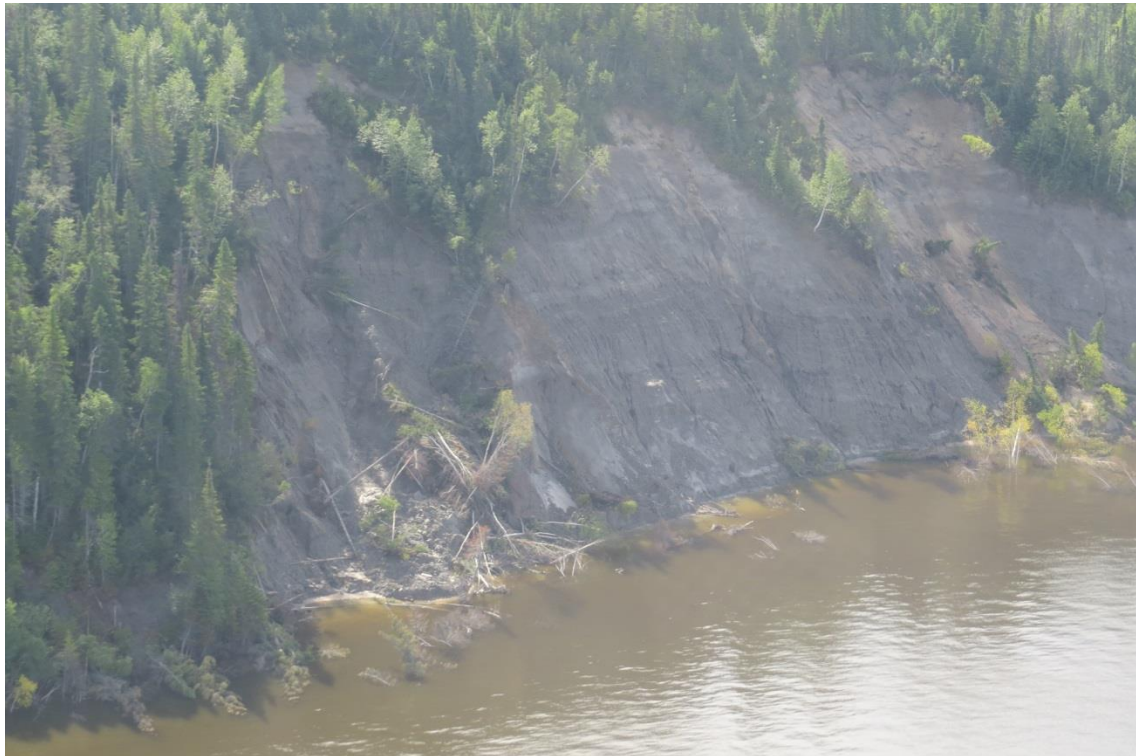
Figure 1: Active erosion approx. 67 to 68 Km, South Bank

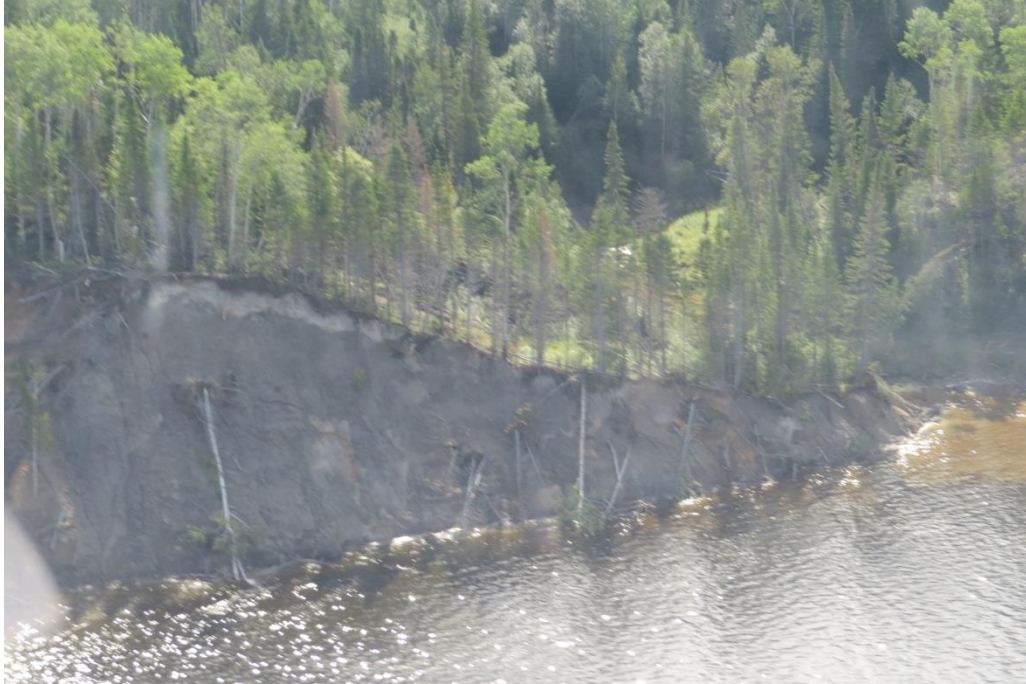
Figure 3: New trees at 91 km, South Bank

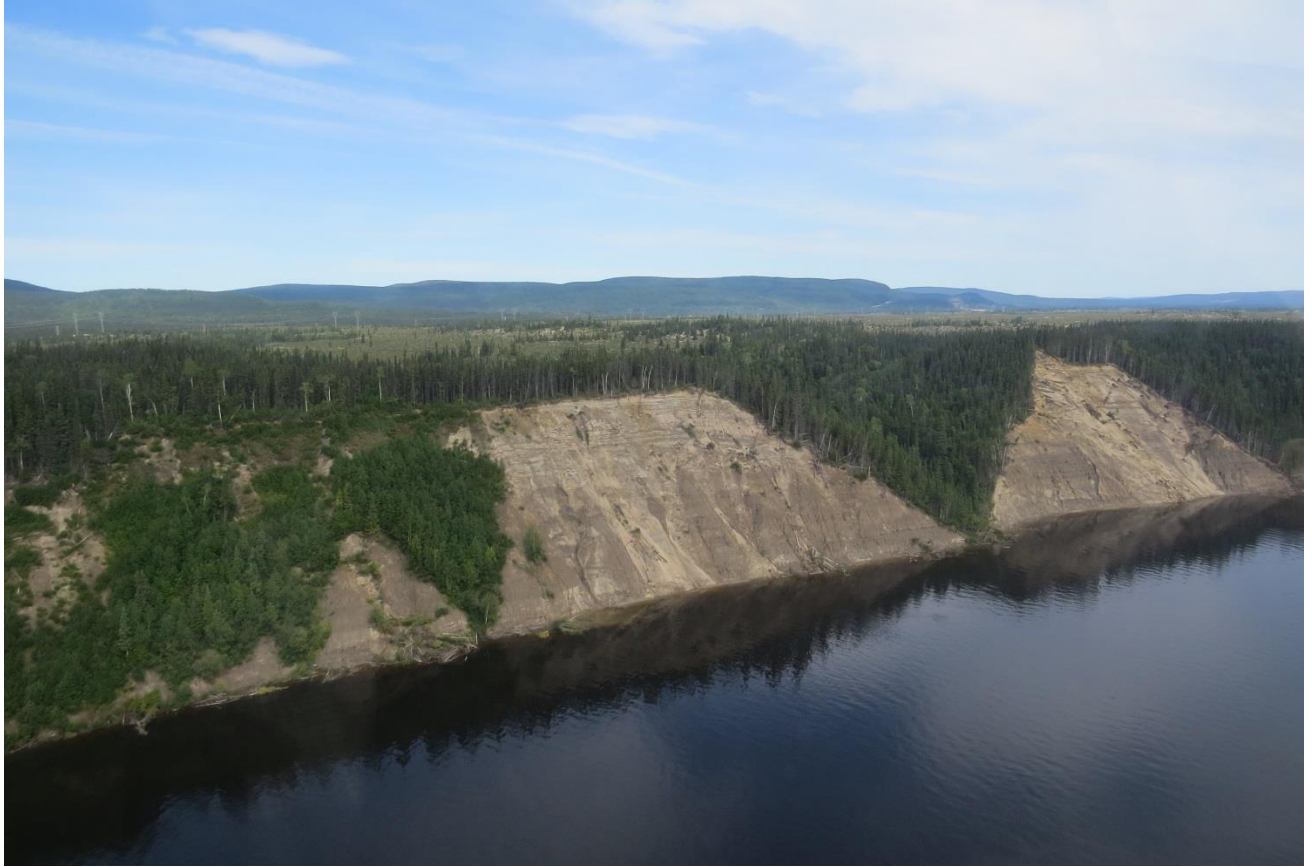
Figure 7: Active erosion at approx. 49 to 45 km, North Bank
