Reservoir Survey Report

Date: 25-Aug-2017

Surveyed River Area: From Muskrat Falls Site to Gull Island Lake

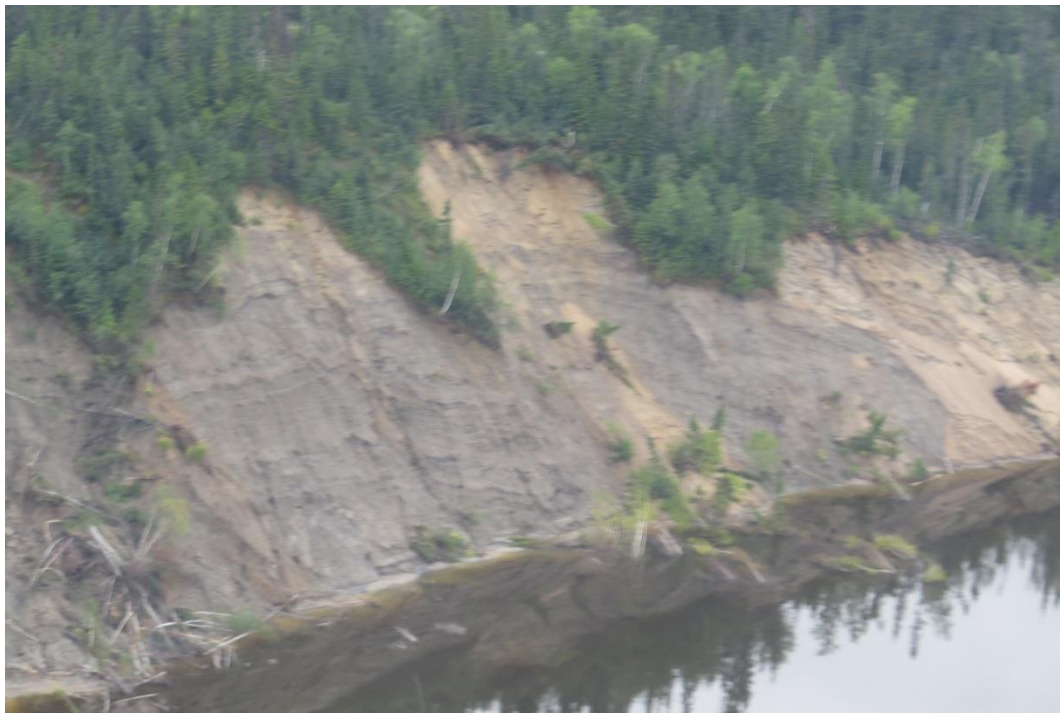
Figure 1: Between 67 to 68 Km, South Bank (Active Erosion)

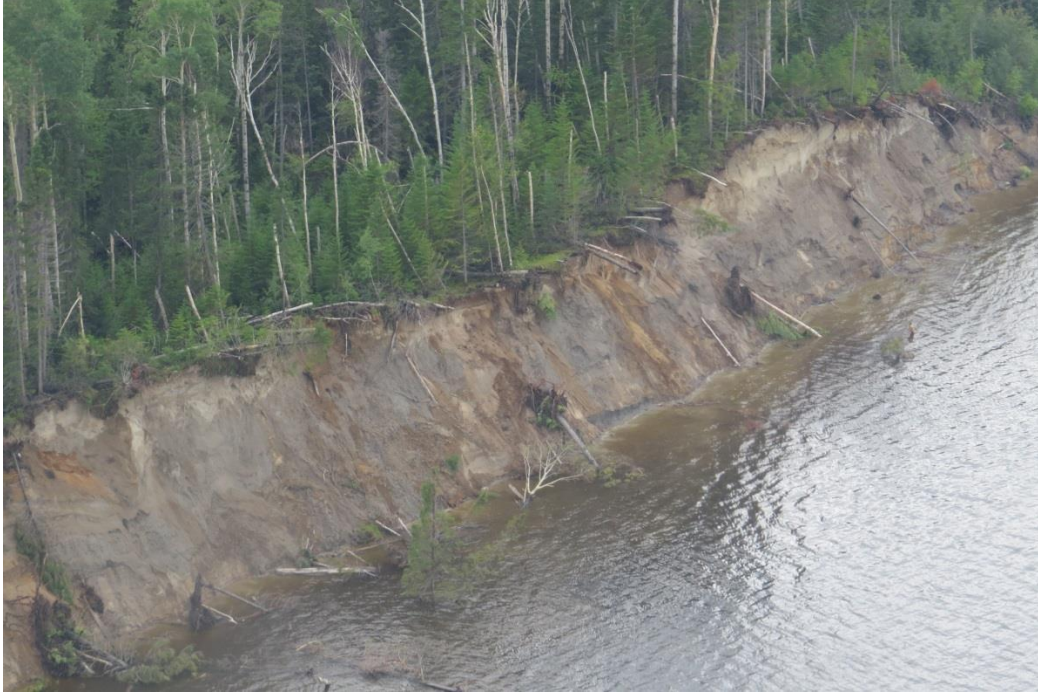
Figure 2: Active erosion South Bank, 82 Km

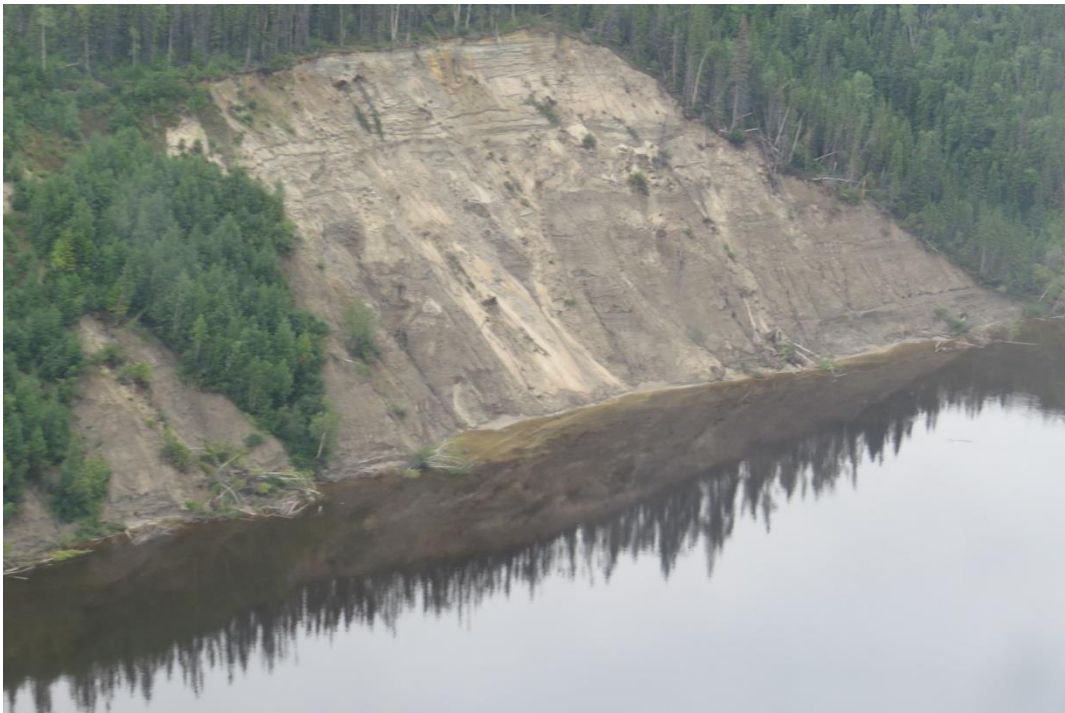
Figure 3: About 48 km North Bank, some sediment (active erosion)

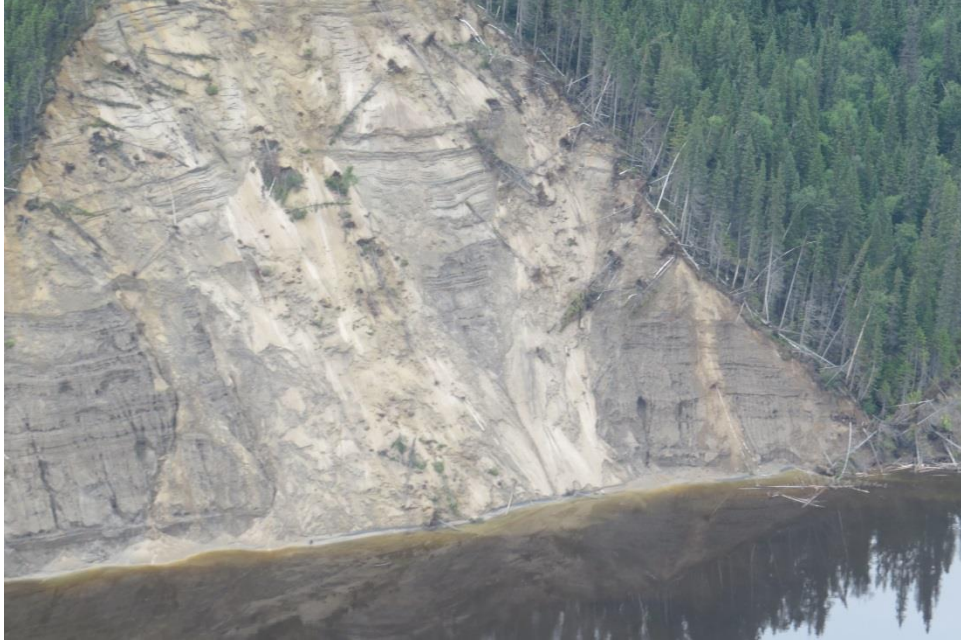
Figure 4: Kilometer 48 North Bank, active erosion
