Reservoir Survey

Date: 11-Aug-2017

Surveyed River Area: From Muskrat Falls Site to Gull Island Site

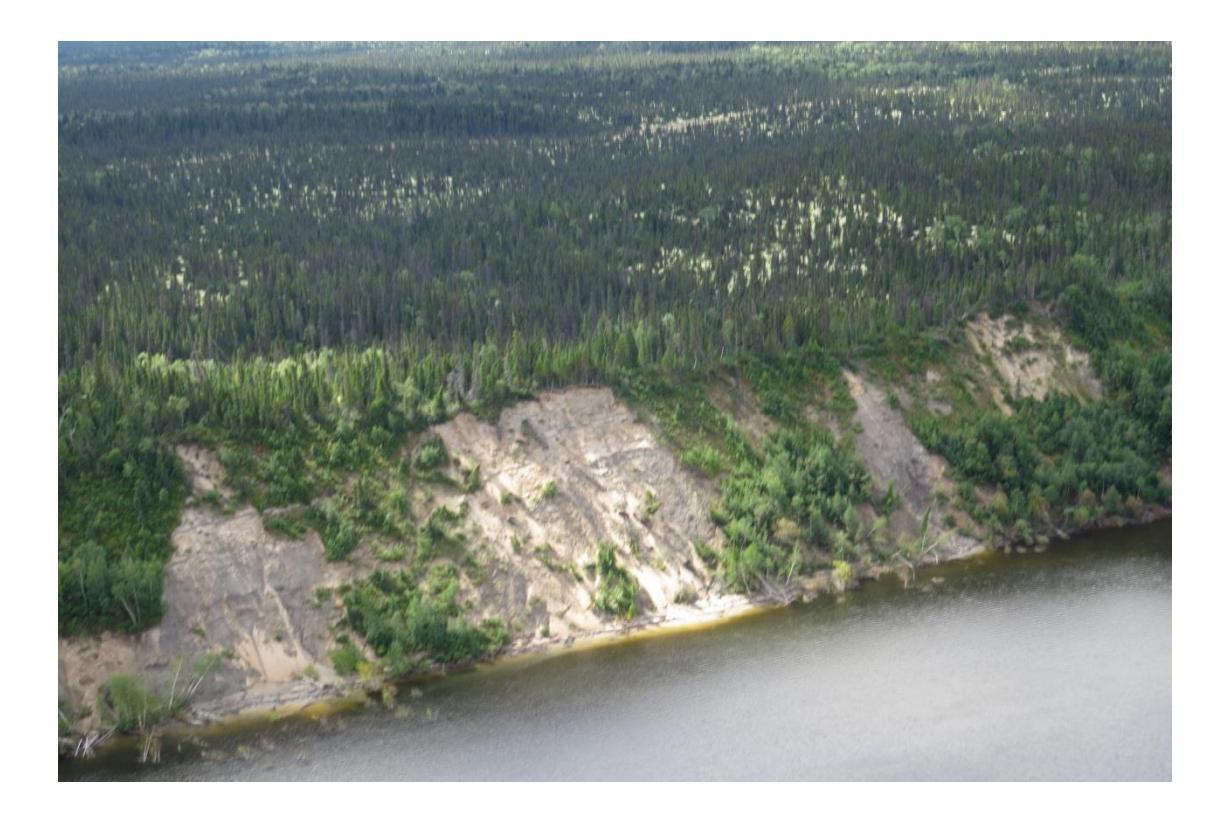
Figure 1: Between 67 to 68 Km, South Bank (Active Erosion)

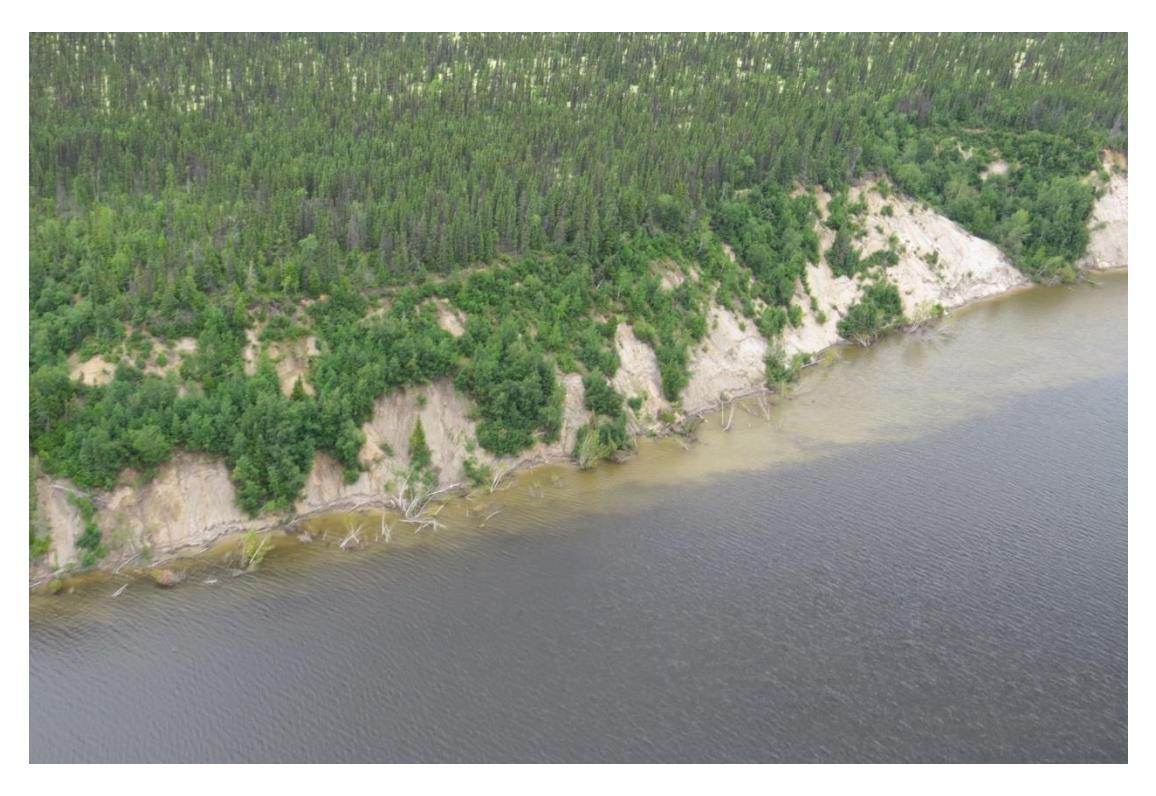
Erosion ongoing in sloped surfaces with no green cover and sedimentation was still observed between kilometers 49 to 44 on the North Bank of the reservoir. No new slides or unusual conditions to report at this time.

Figure 2: About 48 km, North Bank, Sedimentation
