## Reservoir Survey

**Date:** 05-Aug-2017

**Surveyed River Area:** From Muskrat Falls Site to Gull Island Site

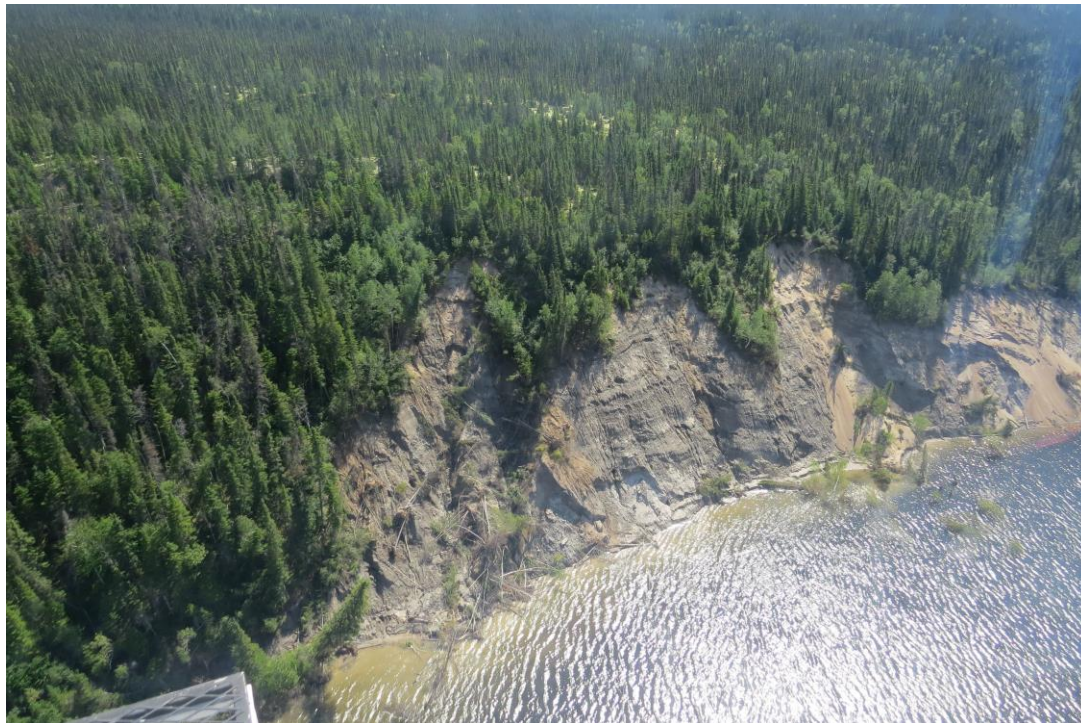
**Figure 1: Between 67 to 68 Km, South Bank**

Kilometer	Sedimentation/Shoals	Slopes/Sloughs/Slides	Conditions
44 to 48	None	None	Normal
48 to 51	Shoals along the edge	None	Slow Erosion
51 to 60	Some shoals visible	None	Green cover/Sand deposit
60 to 66	Some shoals/ little sedimentation	No new slide	Active erosion
66 to 68	None	Two fresh slides – No change since last inspection	Active erosion
68 to 70	Shoals	Smaller slopes	Active erosion
70 to 72	None	None	Green covered
72 to 78	Some shoals visible	Smaller slopes	Active erosion
78 to 81	Shoals	Small slope failures	Active erosion
81 to 84	None	None	Stable (Green and Gravel beach)
84 to 85	None	Fresh slides – not new	Rapid water/large slopes
85 to 88	None	None	Stable (Green and Gravel beach)
88 to 90	None	Two fresh slides	Some active erosion
90 to 92	Shoals	None	Gravel beach banks – stable
92 to 95	Shoals with gravel on top	Steep slopes with no green	Active erosion

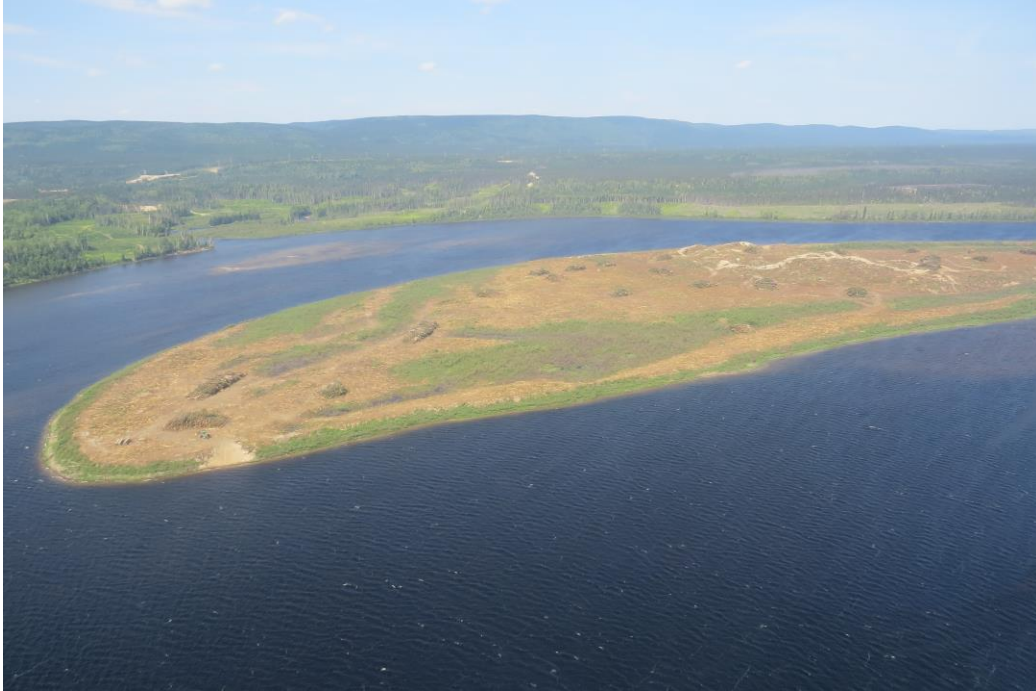
**Figure 2: Edwards Island clearing completed**

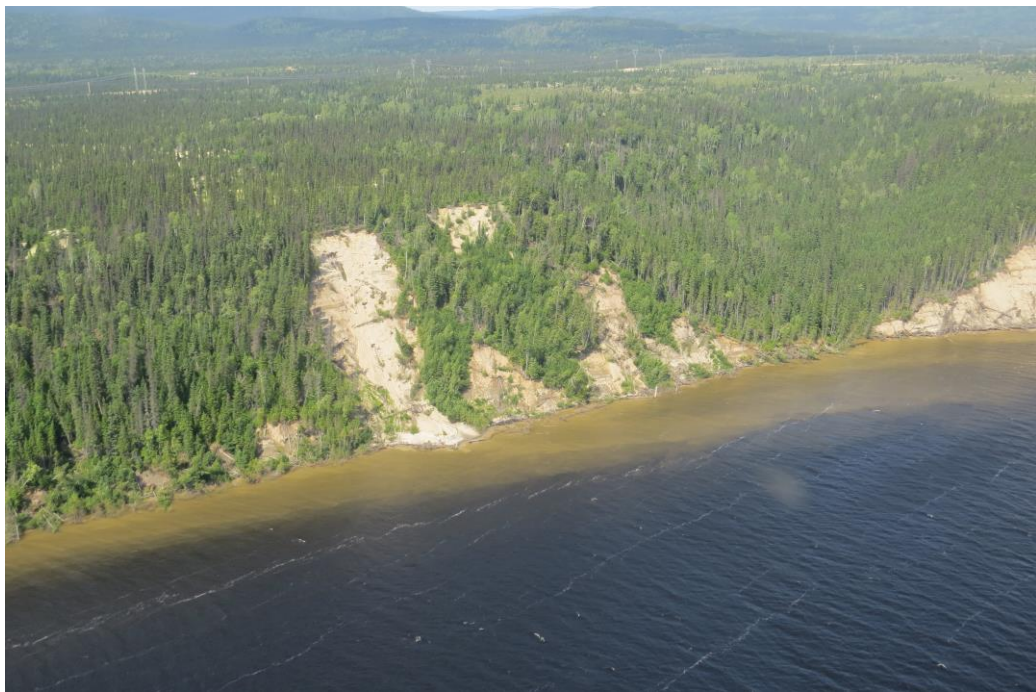
**Figure 3: About 78 km, Left Bank**

Kilometer	Sedimentation/Shoals	Slopes/Sloughs/Slides	Conditions
95 to 84	Shoals – sometimes with gravel on top	None	Stable –gravel and green edges
84 to 80	Few shoals	None – few steep areas	Active erosion – with sedimentation
80 to 76	Little sedimentation	None	Active erosion/ sedimentation
76 to 70	Little sedimentation	None	Mostly Stable
70 to 60	Little sedimentation	None	Mostly Stable
60 to 56	Heavy Sedimentation	Steep slopes –no green	Active erosion
56 to 52	Few shoals	None	Stable –all green
52 to 49	Little sedimentation	None	Stable –all green
49 to 46	Heavy Sedimentation	None	Green covered
46 to 43	None	None	Stable
