Reservoir Survey

Date: 5-Jul-2017

Surveyed River Area: From Muskrat Falls Site to Gull Island Site

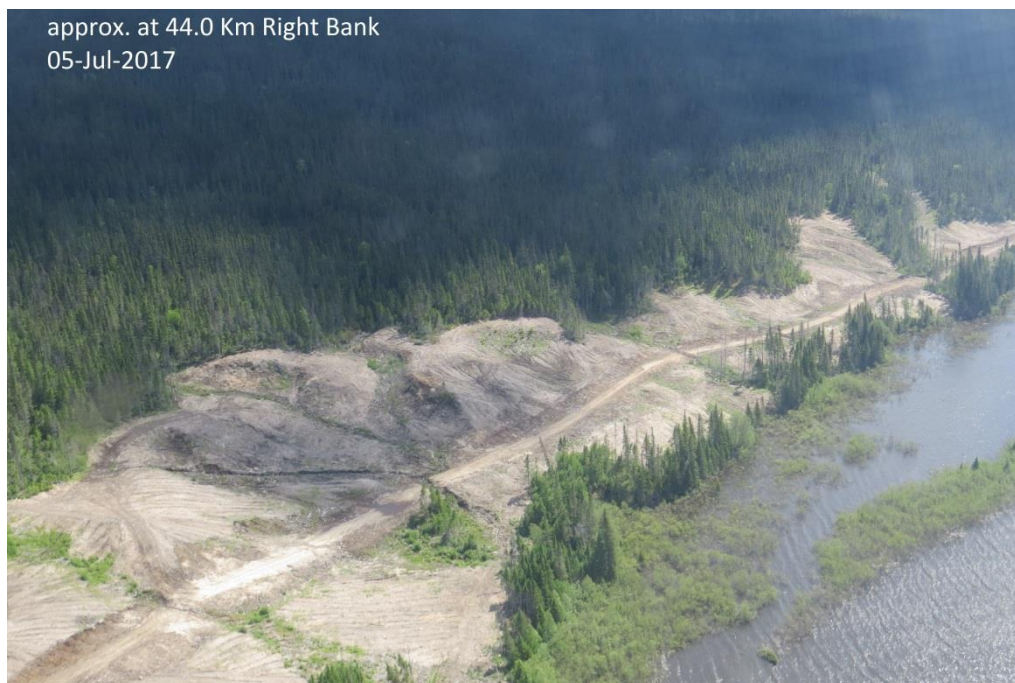
Close to Muskrat Falls Site there are very little steep edges along the river on the Right Bank, most banks are already filled with water with no noticeable sedimentation at this time.

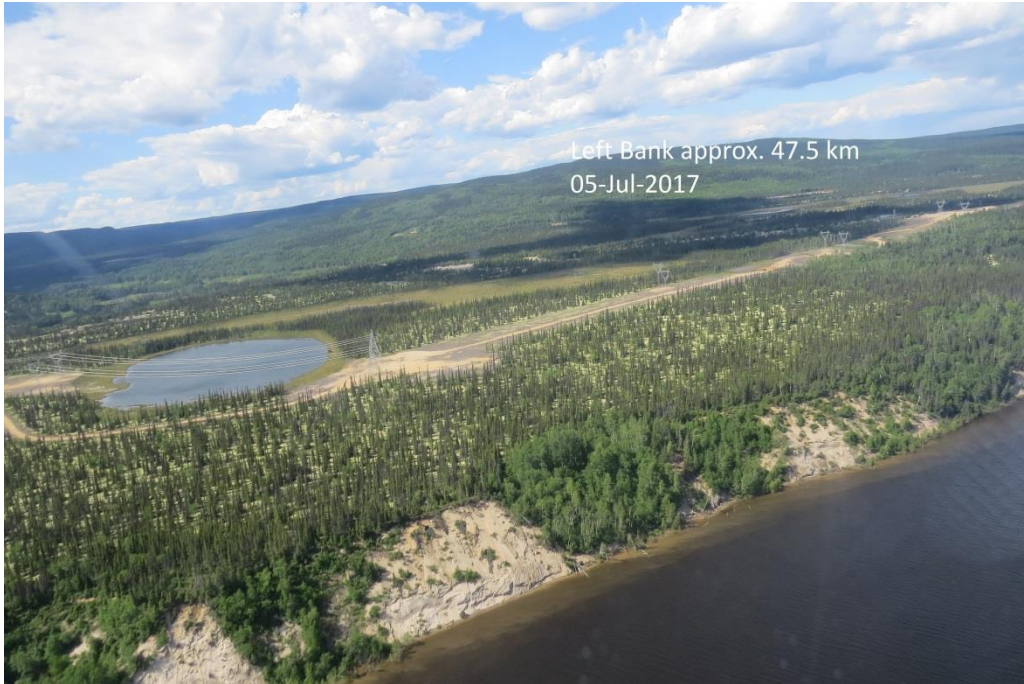
While, on the left bank near North Spur Site some steep slopes with no tree covering showed signs of erosion as washing sediments could be clearly seen in the picture below.

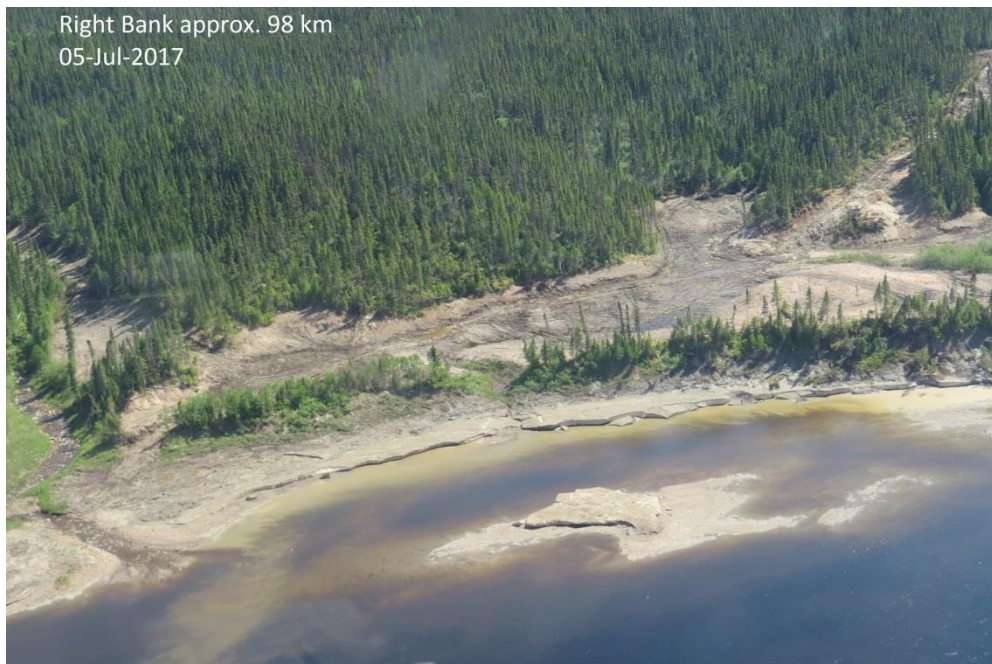
Close to Gull rapids between Kilometers 94 to 100, a few scattered chunks of ice were still present. The slopes along the river in this have no steep edges, little sedimentation and green covering along the banks. A few shoals were also visible in this area at this time.
