Reservoir Survey

Performed by: Regis Bouchard

Date: 21-Jul-2017 **Time:** 1:00 – 2:00 PM

Surveyed River Area: From Muskrat Falls Site to Gull Island Site

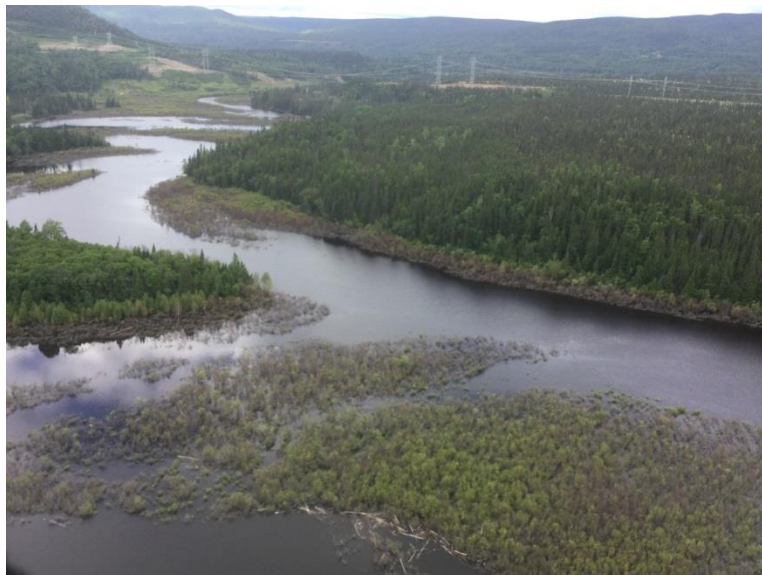
Pay attention to picture 2015 below showing the Lower Brook where no sediment are visible.

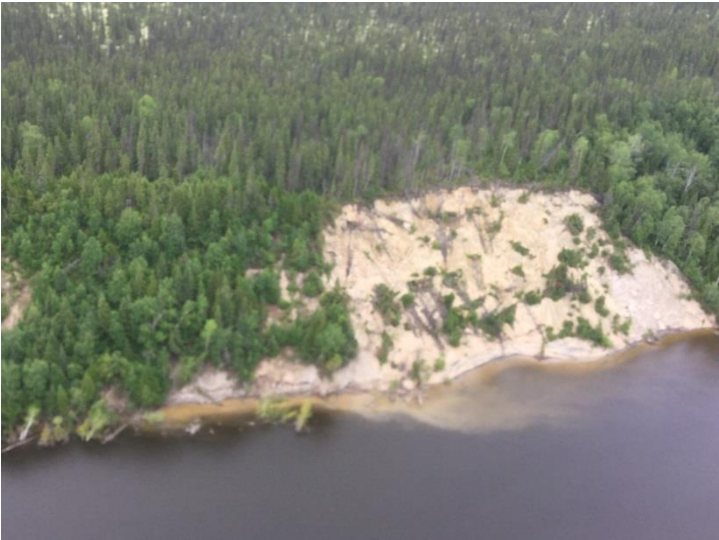
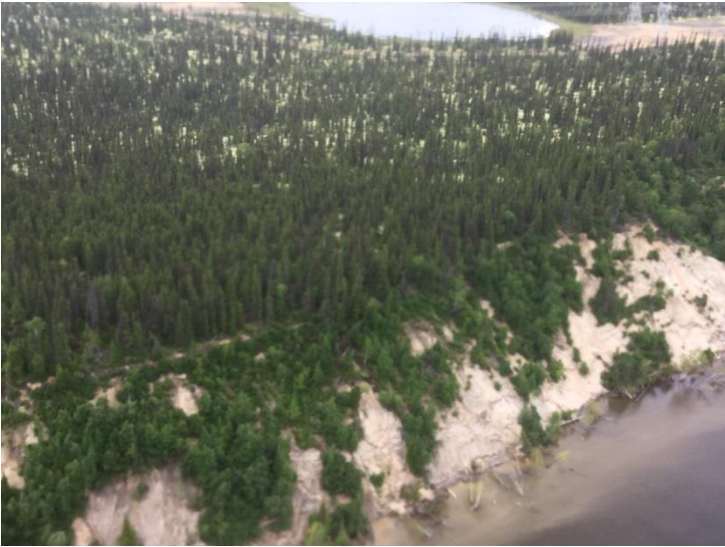
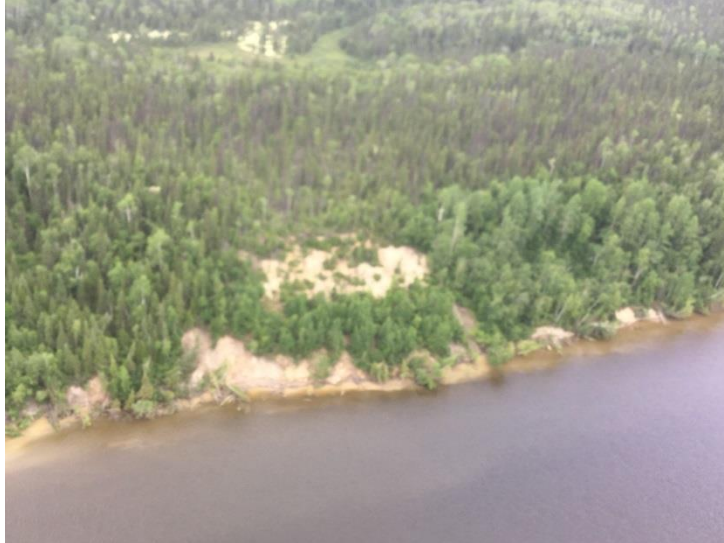
Downstream Lower Brook, following pictures show few erosion at the bottom of the slope between KM 49 to 46. Pictures below show what I talking about.

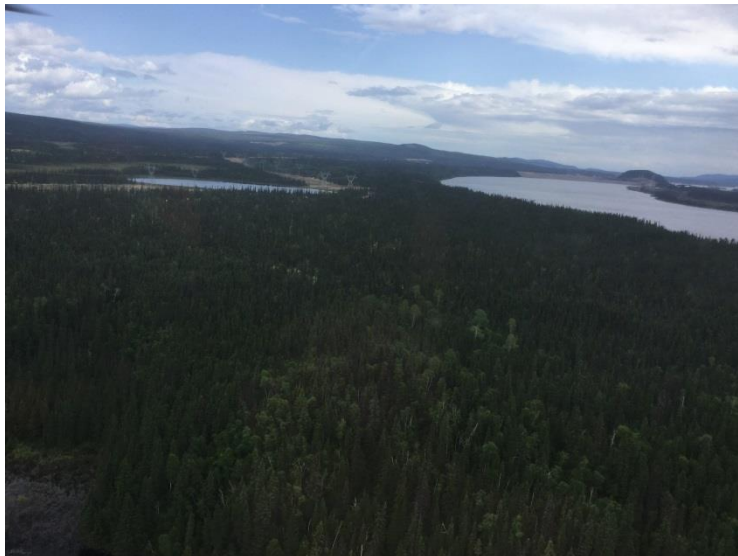
The wind was from east today, no wave effect, so erosion process is low today. Water is visible at the surface of the upper plateau over the slope at KM 47.5.
