Is the North Spur dam safe?

I have written several articles about my concerns regarding the safety of the North Spur dam, concluding in my last article that the dam was not safe. However, on undertaking a more detailed analysis of the NALCOR reports, I have changed my mind, and now believe the dam to be safe.

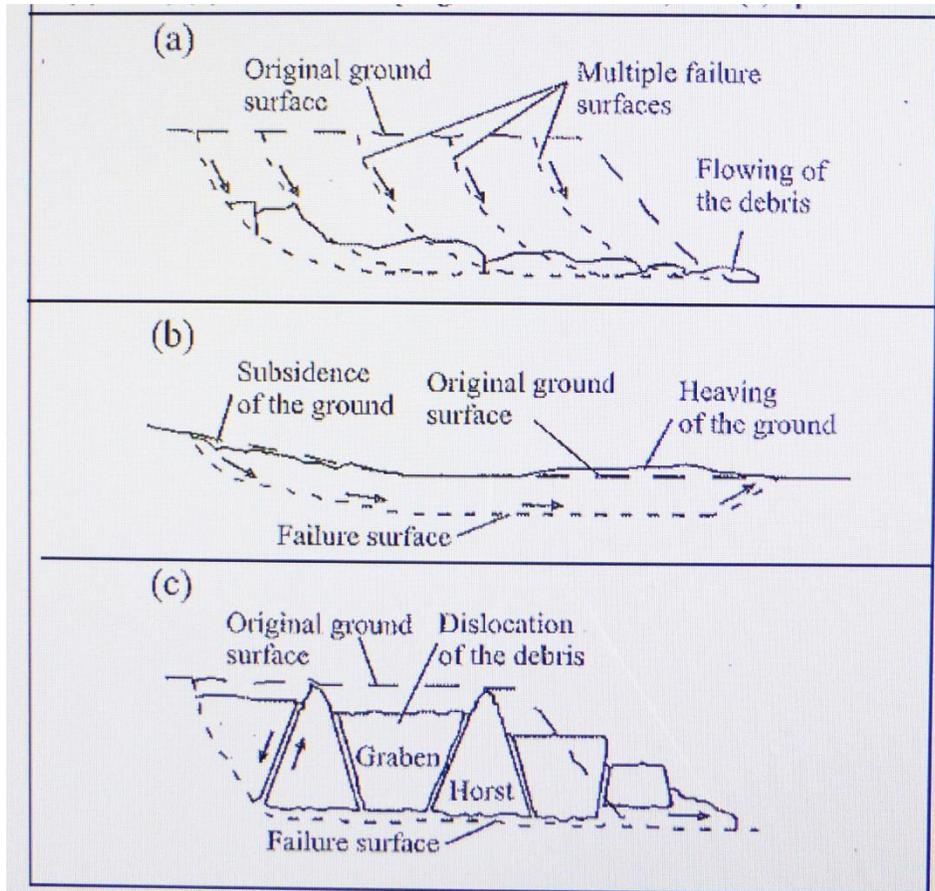
(a) Flowslide (b) Downhill progressive landslide. (c) Uphill progressive landslide.

Source Dr. Ariane Locat, Serge Leroueil, Stig Bernander, Denis Demers, Hans Petter Jostad, Lyes Ouehb . “Progressive failures in Eastern Canadian and Scandinavian sensitive clays” Canadian Geotechnical Journal, 2011. 48 (11).

My initial concerns centered on the report by Dr. Bernander identifying many progressive landslides in the river valley near the North Spur. What is a progressive landslide – it is a landslide which can occur in soft (quick) clays where the land mass slides downhill on failure of a weak zone below the surface, as shown in Figure 1, sections (b) and (c).

As defined by Dr. A. Locat *“the concept of progressive failure may explain translational progressive landslides and spreads — large landslides occurring in sensitive clays. During progressive failure, the strain-softening behaviour of the soil causes unstable forces to propagate a failure surface further in the slope. Translational progressive landslides generally take place in long, gently inclined slopes. Instability in a steeper upslope area is followed by redistribution of stress, which increases earth pressure further downslope.”* Source – Abstract to paper referenced in Figure 1.

Dr. Bernander, after inspecting the river banks and the North Spur shoreline, concluded “For the most recent large slide in the North Spur, in 1978, Nalcor’s own engineers found that the silty clay layer **had developed multiple failure surfaces and liquefied over a long lateral distance**”. Sources Bernander 2015 report, pages 7. No such statement could be found in the NALCOR 2015 report, on liquefaction in the 1978 landslide. In fact, the landslide is identified as being of the flow type – see Figure 1 (a) – “The slide involved a block movement triggered by weak layers

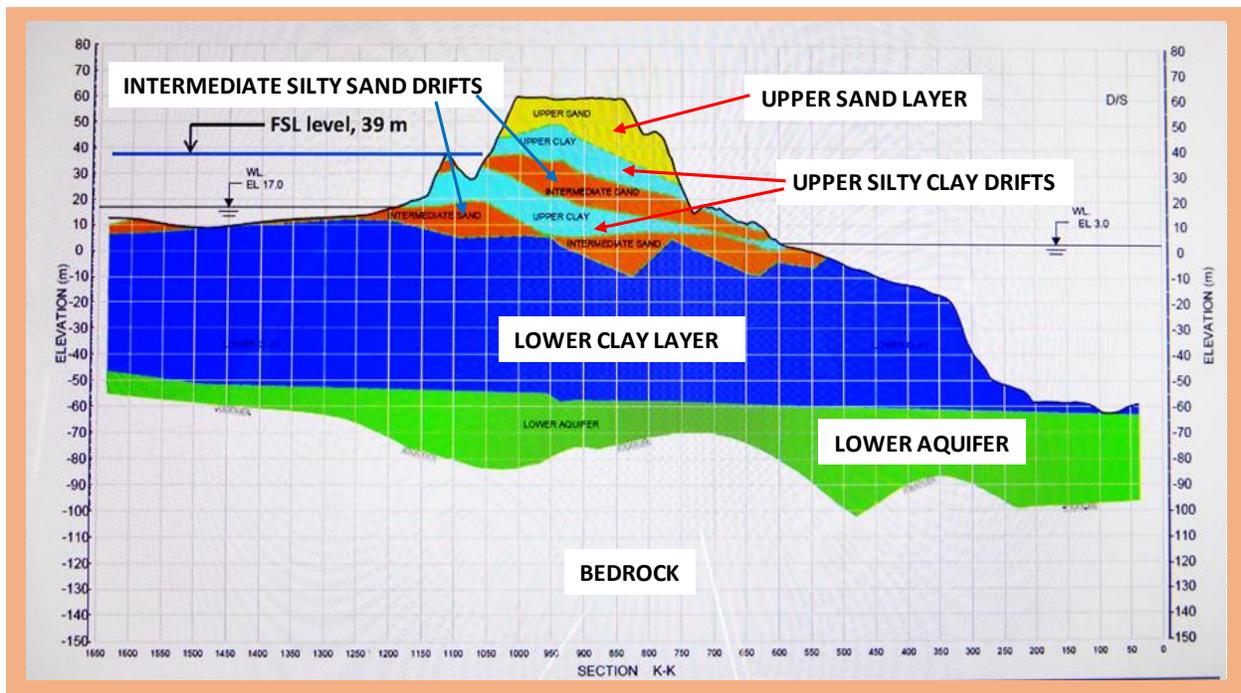
Figure 2.

Section through the North Spur – vertical scale exaggerated for clarity. Shows the layers of sands and clays within the Spur. Source – North Spur Updated, Independent Engineer, 21.7.14.

A few tests on soil samples retrieved from the two "Upper Silty Clay Drifts" – see Figure 2 have indicated the presence of soft clays. The sensitivity ranged from 1 to 36 in 43 samples, with an average of 10. Source NALCOR 2016 report. Page 91. This is not soft enough to be considered "quick", according to Carlton U. Moreover, during the excavation work required to re-shape the North Spur, there were no instances of liquefaction nor small landslides. All clay removed by shovels and dumped into trucks remained in clumps. This indicates that the pockets of quick clay (if any) were far too small to cause landslides.

Dr. Bernander also reviewed the data available on the lower clay layer (See figure 2). This layer provides the foundation for all the soils above water level in the North Spur. Again, Dr, Bernander concludes *"... that layers with high sensitivity also occur in the Lower Clay formation — a fact that allows the possibility of developing a progressive failure"*. Source Bernander 2016 report, page 8.
