Muskrat Falls Generation Project

Dam Safety Weekly Monitoring Summary Report

August 26 to September 1, 2019

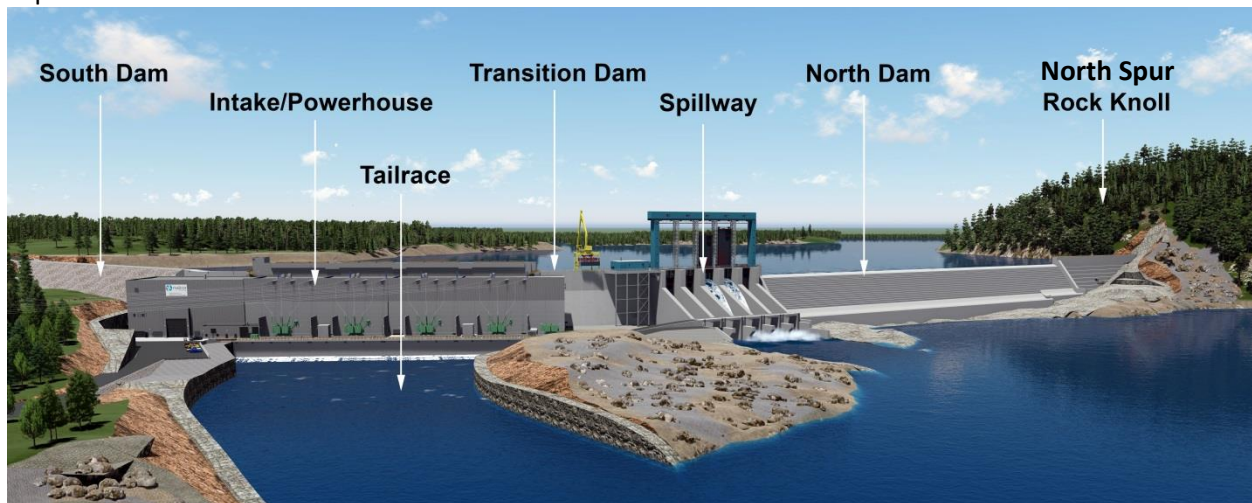
Our dam safety monitoring is designed to assess the effects of the force or pressure of the water from the reservoir on permanent structures including the South Dam, Powerhouse, Spillway, North Dam, North Spur and three Transition Dams. The following illustration shows the various structures and explains their function.

South Dam	Powerhouse	Intake & Tailrace	Spillway	Transition Dams	North Dam	North Spur
Conventional rock-fill till-core dam that closes the south part of the reservoir between the south bank and Powerhouse.	Houses the four generating units.	The Intake draws water from the river into the Powerhouse. Water exits the Powerhouse through the Tailrace.	Primary function is to pass the water that is not required to generate electricity in the Powerhouse.	Concrete dams to make the connection between the South Dam & Powerhouse; Powerhouse & Spillway; and Spillway & North Dam.	Concrete dam used to close the north part of the reservoir.	This is a natural dam that has been reinforced.
