Muskrat Falls Generation Project

Dam Safety Weekly Monitoring Summary Report

September 16 to September 22, 2019

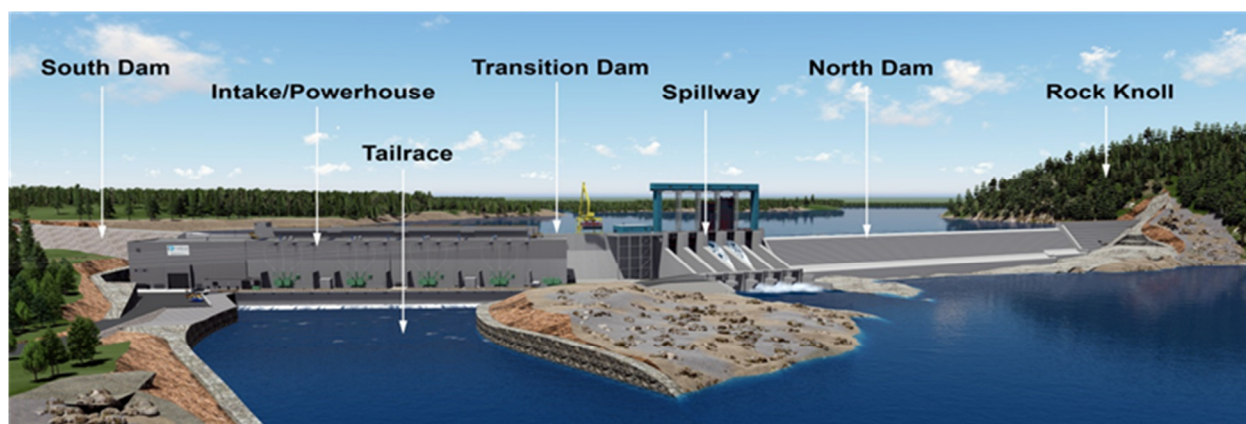
Our dam safety monitoring is designed to assess the effects of the force or pressure of the water from the reservoir on permanent structures including the South Dam, Powerhouse, Spillway, North Dam, North Spur and three Transition Dams. The following illustration shows the various structures and explains their function.

South Dam	Powerhouse	Intake & Tailrace	Spillway	Transition Dams	North Dam	North Spur
Conventional rock-fill till-core dam that closes the south part of the reservoir between the south bank and Powerhouse.	Houses the four generating units.	The Intake draws water from the river into the Powerhouse. Water exits the Powerhouse through the Tailrace.	Primary function is to pass the water that is not required to generate electricity in the Powerhouse.	Concrete dams to make the connection between the South Dam & Powerhouse; Powerhouse & Spillway; and Spillway & North Dam.	Concrete dam used to close the north part of the reservoir.	This is a natural dam that has been reinforced.
