Muskrat Falls Generation Project

Dam Safety Weekly Monitoring Summary Report
September 9 to September 15, 2019

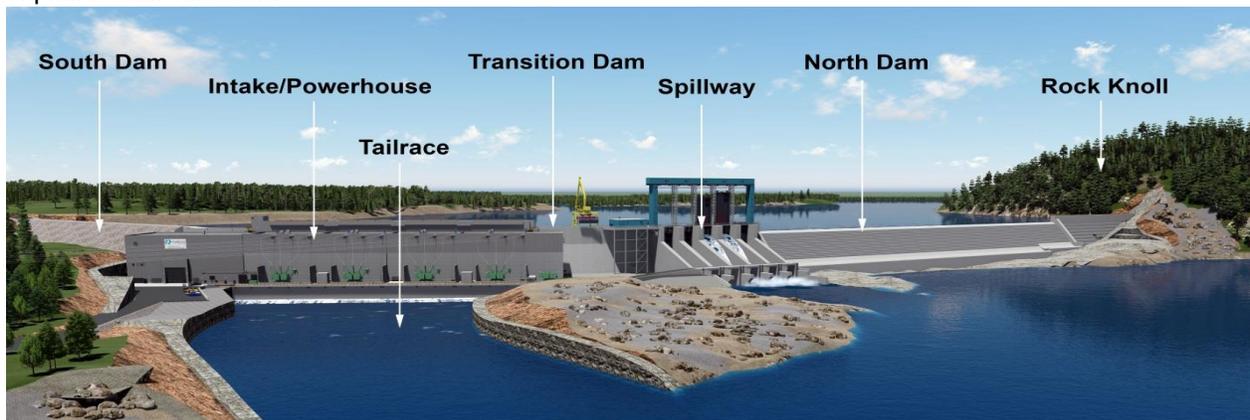
Our dam safety monitoring is designed to assess the effects of the force or pressure of the water from the reservoir on permanent structures including the South Dam, Powerhouse, Spillway, North Dam, North Spur and three Transition Dams. The following illustration shows the various structures and explains their function.

South Dam	Powerhouse	Intake & Tailrace	Spillway	Transition Dams	North Dam	North Spur
Conventional rock-fill till-core dam that closes the south part of the reservoir between the south bank and Powerhouse.	Houses the four generating units.	The Intake draws water from the river into the Powerhouse. Water exits the Powerhouse through the Tailrace.	Primary function is to pass the water that is not required to generate electricity in the Powerhouse.	Concrete dams to make the connection between the South Dam & Powerhouse; Powerhouse & Spillway; and Spillway & North Dam.	Concrete dam used to close the north part of the reservoir.	This is a natural dam that has been reinforced.
