## Update from Nalcor on the Spillway operation at Muskrat Falls – Feb. 10, 2017

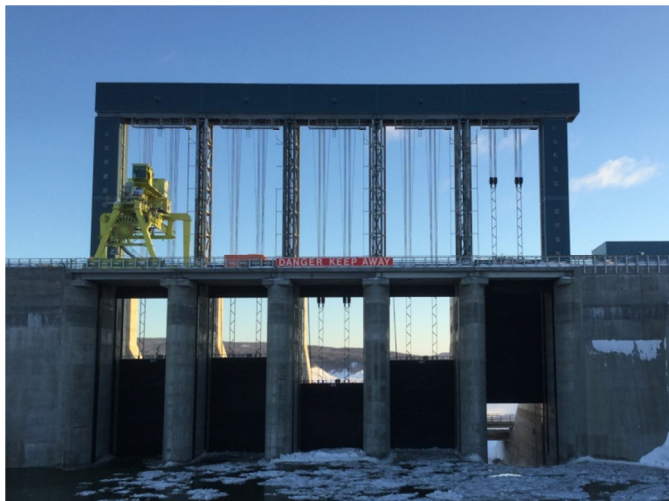
*Upstream side of the spillway on February 10, 2017. Gate 3 remains closed; Gates 2, 4 and 5 remain partially closed; Gate 1 remains open. Gates are numbered 1 to 5 from right to left.*
